The GB Water Primrose *Ludwigia grandiflora* eradication programme: 2017 progress report

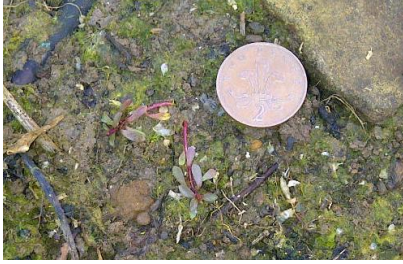
There are both drawbacks and benefits to this approach. The dispersed network of coordinators provides less direct control over the programme. In the short-term this may slow the progress of control at some sites, however, the benefits are significant. It is hard to eradicate water primrose, and tiny regrowth can persist for a number of years (see image). A site

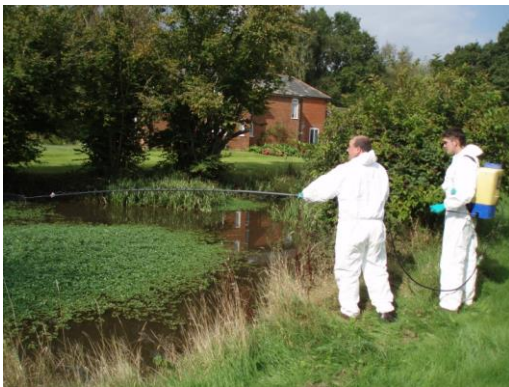
Most water primrose management has been performed using glyphosate-based herbicides, often in conjunction with adjuvants such as 'Topfilm'. This method has proved effective in reducing biomass, but requires repeated applications over a number of years and often results in tiny fragments surviving in the soil. Fluctuating water levels, particularly during the wet summer and autumn periods, complicates treatment and reduces efficacy.

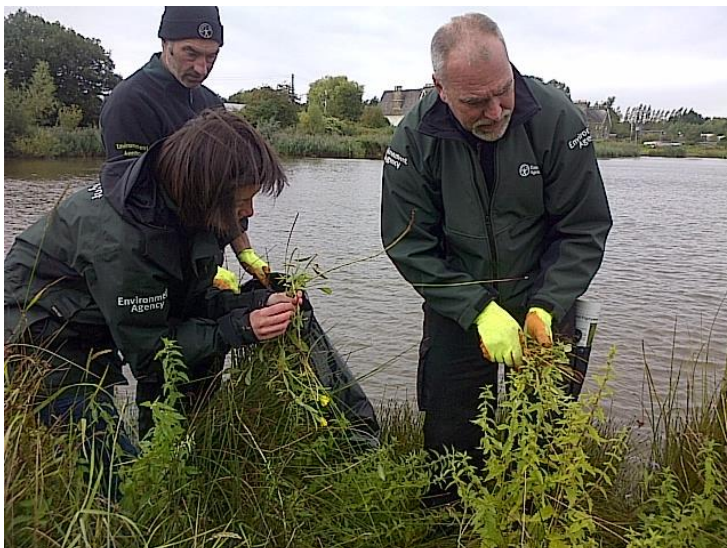
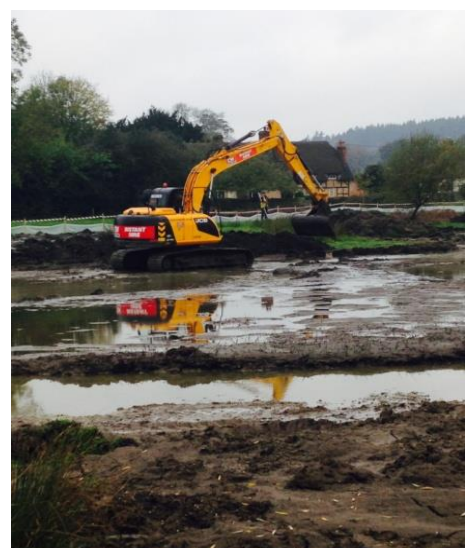
landowners are often reluctant to allow the disturbance associated with this control method, and disposal issues often complicate matters. The disposal issue has now been simplified by the adoption of a new Regulatory Position Statement allowing the burial of water primrose. In 2014, the largest infestation of water primrose was mechanically excavated, resulted in the removal of approximately 800 tonnes of silt, water primrose and *Crassula helmsii* from Braemore marsh SSSI. Water primrose has subsequently regrown at the site, but all new growth is being regularly manually removed or chemically treated and is limited to isolated plants.

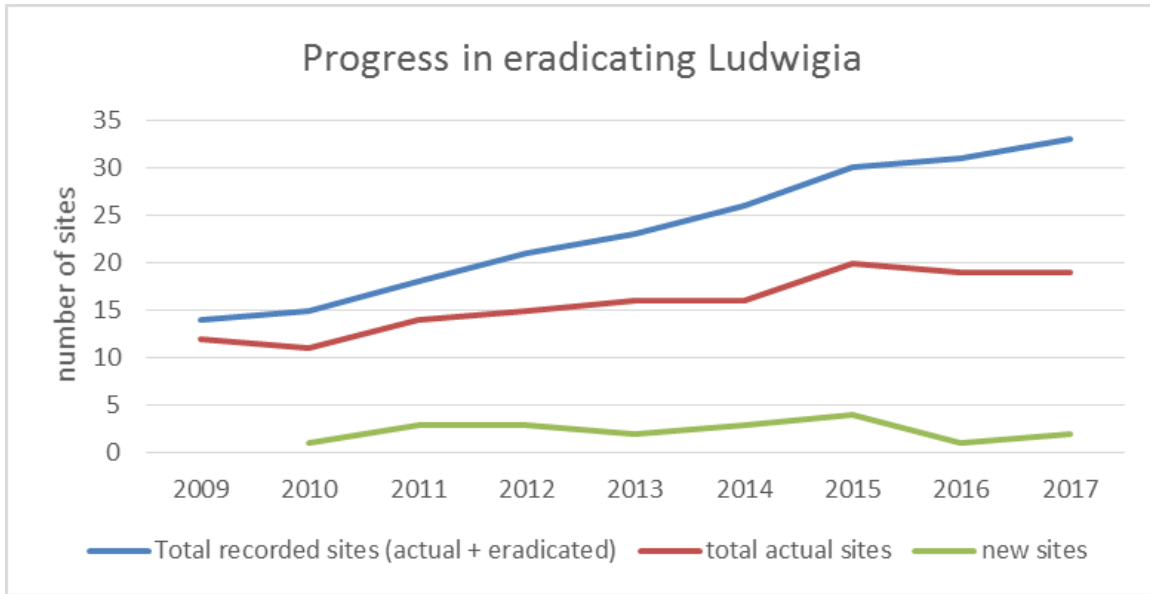
Figure 2. Progress of GB water primrose eradication programme

Figure 2, below, describes the progress to date. There are various aspects of this graph that are encouraging. The blue line, total number of recorded sites (the sum of surviving and eradicated sites), is describing a declining trend, rather than the exponential increase normally associated with the distribution of an invasive non-native species. The red line, total number of surviving sites, appears to have plateaued and may be beginning to describe a slow decline, but it is too early to tell. The green line, the number of new sites, has declined. A positive interpretation of these trends would suggest that the combination of a ban on sale, improving public awareness, effective management and good biosecurity is resulting in a decline in the GB water primrose population. A less optimistic interpretation may interpret the reduced trend in new sites to less awareness of water primrose and the need to report its presence.

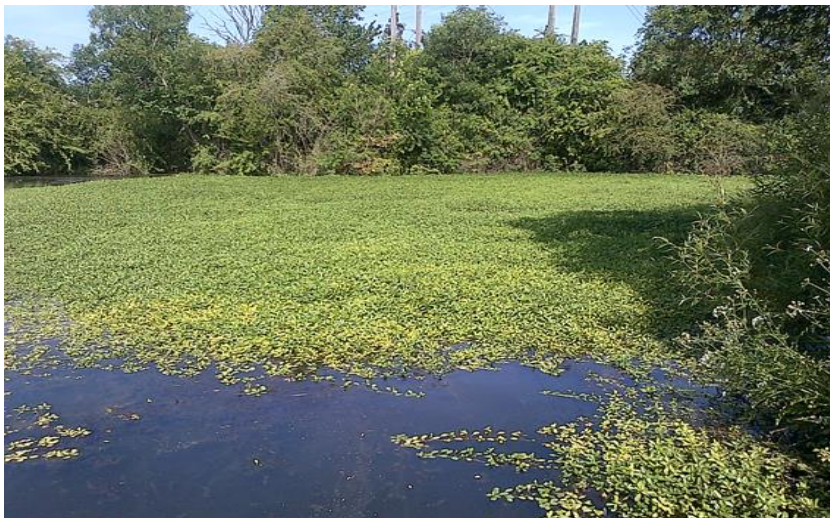
The total surface area of water primrose from known UK sites is 858.5 m². Of this area, 650 m² is due to a single fishery near Bridgwater, Somerset, discovered in 2017 and already undergoing treatment (below). The remaining 208.5 m² constitutes the total area of the other 18 sites in treatment, which is an area less than a tennis court.

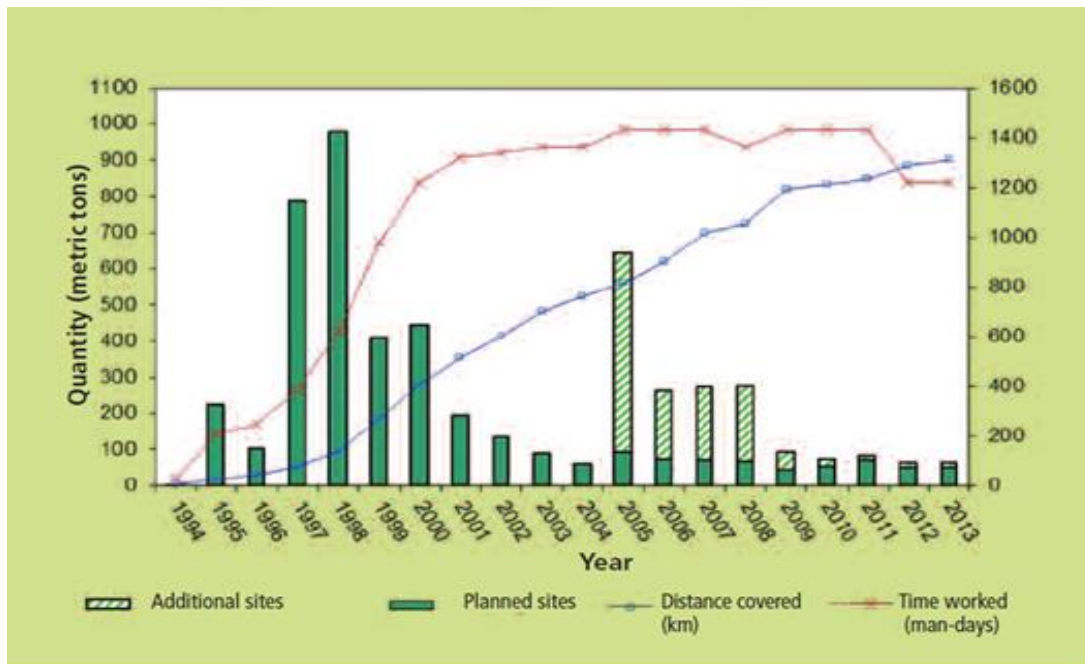
Figure 3: Water primrose management at Marais Poitevin National Park. Credit: Emilie Mazaubert, IIBSN

In comparison, water primrose has achieved phenomenal spread elsewhere in its invaded range. In Japan, water primrose covered 30 ha of Lake Biwa in 2016 within seven years of its first arrival. At Marais Poitevin National Park, France, 1000 tons of water primrose was extracted four years after its initial establishment in 1994. Despite this effort, the authorities treated 1311km of primrose-infested riverbank in 2013 (Figure 3, next page).
